Post-Construction Landfill Liner Failure and Lessons Learned

Richard Thiel, P.E., Vector Engineering, Inc, Grass Valley, CA, USA

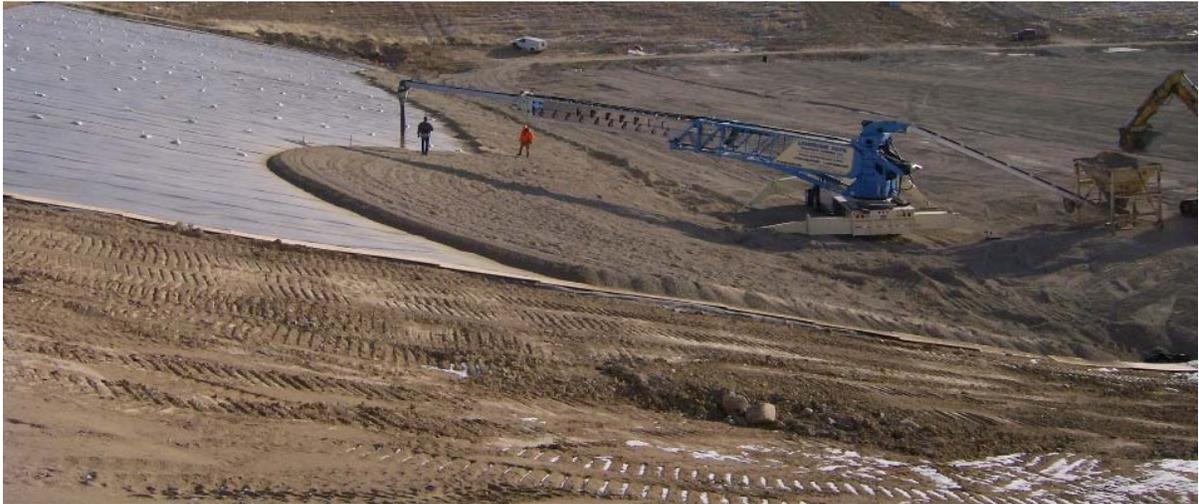
After experiencing that small failure, for which the Contractor took full responsibility, the Contractor decided to take extra caution when placing gravel on the 4:1 slope. Instead of placing and spreading gravel in the traditional manner of dumping at the toe and pushing upslope with a dozer, the Contractor elected to place all of the gravel using a "telebelt" (Figure 1). The telebelt could extend approximately 36 m, and place the desired gravel thickness relatively precisely at all slope locations using a cantilevered conveyor belt using a remote control joystick. By using the telebelt from both the bottom and the top of the slope, no piece of construction equipment was ever required to get on the slope, and the exact thickness of gravel (300 mm) was able to accurately be placed everywhere in a gentle manner. Note that this method of placement, while not extremely rare, is not common because it is substantially more expensive than the traditional method of dumping and dozer-spreading. The Contractor decided to absorb the extra cost of doing the work in this manner rather than take a chance of creating any potential slippage after his experience in the more gently sloping bottom area.

Figure 1. Placing gravel onto PVC with telebelt on 4:1 slope.

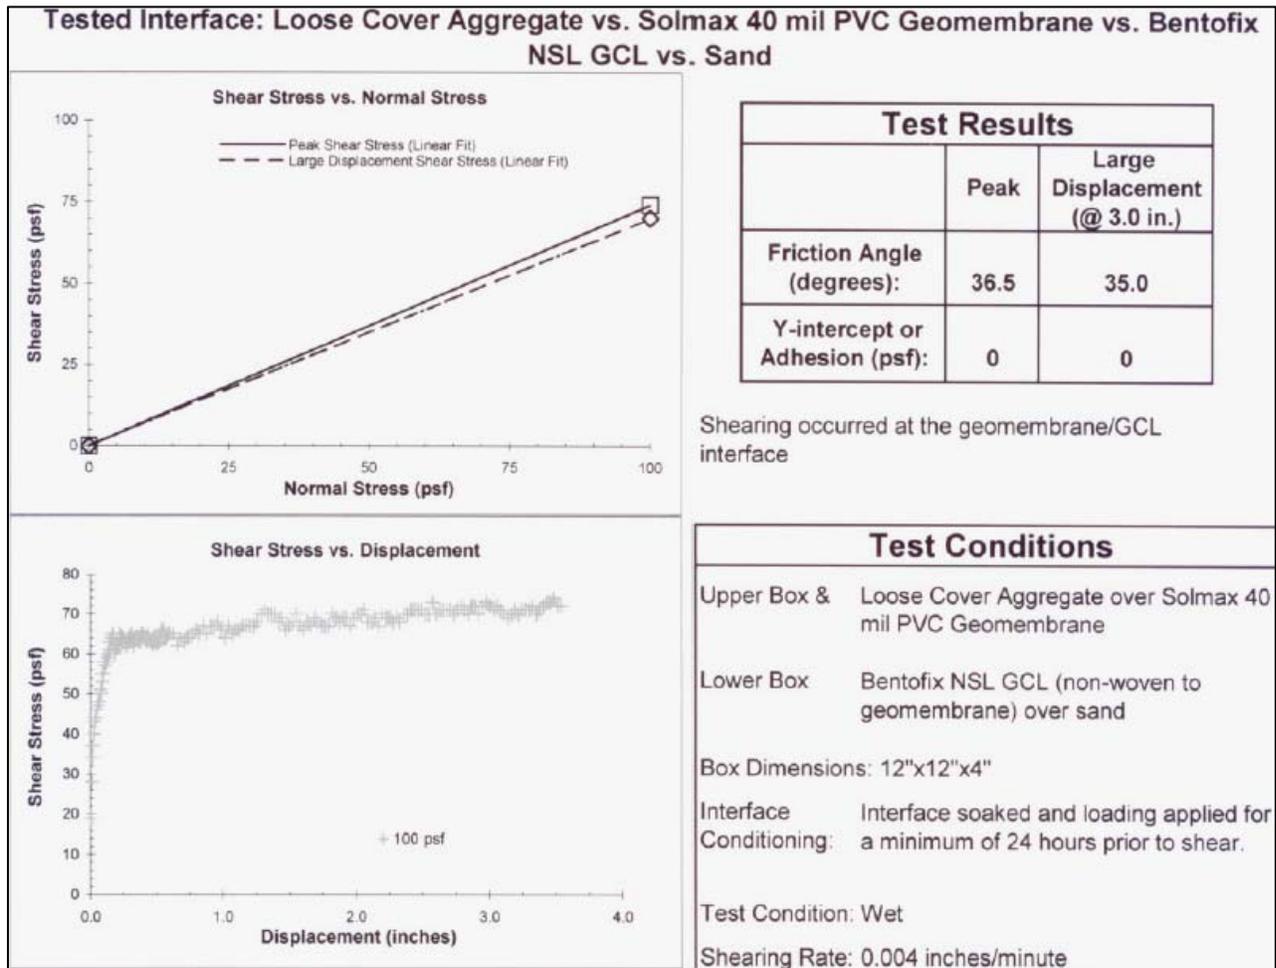
After consultation with the author, the engineer performed additional testing using samples of the exhumed GCL with fresh pieces of PVC. The GCL samples were carefully cut out, wrapped on a plastic pipe core, wrapped with plastic, and placed in sealed bags to preserve their moisture content. In the laboratory, the GCL samples were sandwiched against the PVC, and this was placed between native subgrade soils and gravel to simulated field conditions. The sandwich was hydrated under 4.8 kPa (100 pounds per square foot [psf]) below water for 24 hrs, and sheared at 0.1 mm/min. The tests were performed with a 30 cm by 30 cm square direct-shear box designed specifically for low-normal loads, and the boxes were calibrated to account for machine-friction. The resulting frictional shear strength of approximately 36 degrees peak and 35 degrees post-peak was much too high to be able to predict the failure (Figure 2).

Figure 2. Direct shear test: Interface dry for test assembly, and then submerged after assembly.

The relatively high friction angles achieved in the first round of forensic testing by the engineer were undoubtedly due to the presence of a dry interface between the PVC and the GCL. This condition existed even through the GCL from the field was pre-hydrated through months of subgrade contact, and in spite of having the test sandwich submerged under load for 24 hours. This suggests that even though a GCL may become largely hydrated, it may also preclude free water from getting to the interface in a direct shear test.

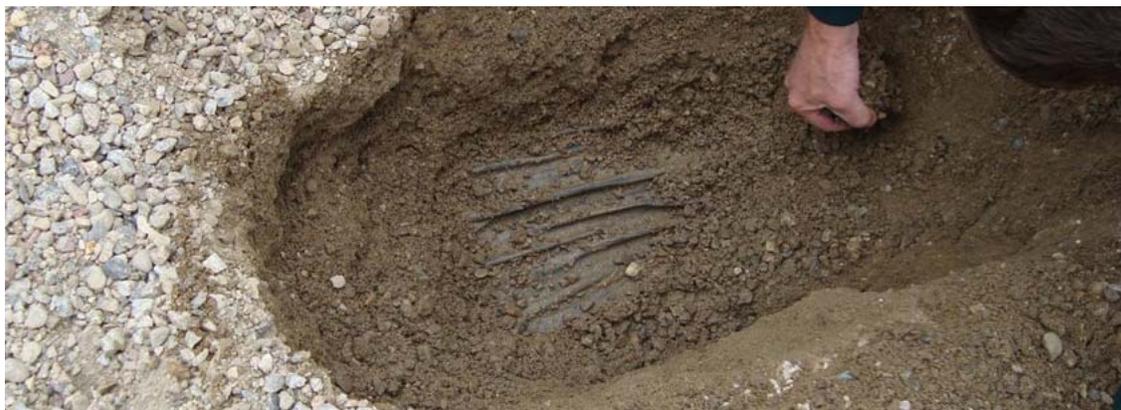
In June the author was requested by the Contractor to visit the site. The failed slope was fully visible, with exposed GCL on the upper half. The exposed GCL was dry because of the arid site conditions. It was clear that the slope had failed from crest-to-toe as evidenced by the presence of bunched-up wrinkles in the PVC at the toe (Figure 3), and bulging and open cracks in the soil cover at the toe (Figure 4). The author shoveled through some of the gravel at the edge of the failed PVC, and lifted the edge of the PVC to observe how the interface looked where it had been protected from meteoric conditions. The surface condition of the exposed un-ripped PVC appeared to be excellent in all cases. The GCL was observed to be normally hydrated (defined by the author as softened to the point that it could be deformed with thumb pressure, but was in no way very soft or oozing), as one would expect from extended contact with the subgrade.

Figure 3. Bunched-up wrinkles in PVC at toe of 4:1 slope.

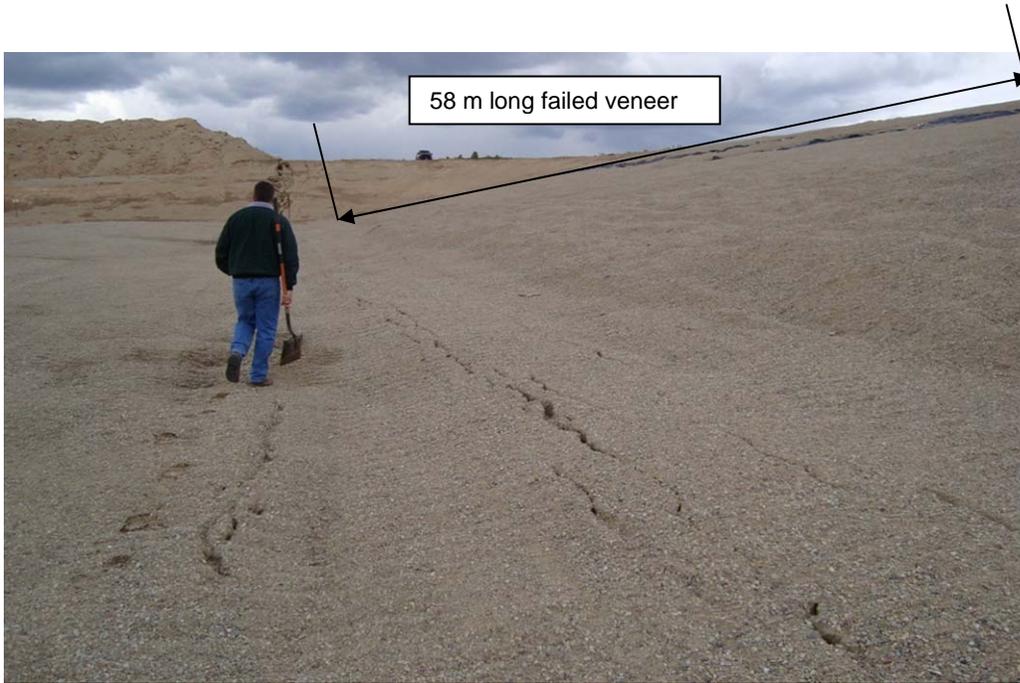
Figure 4. Deformed and cracked cover soils near toe of slope.

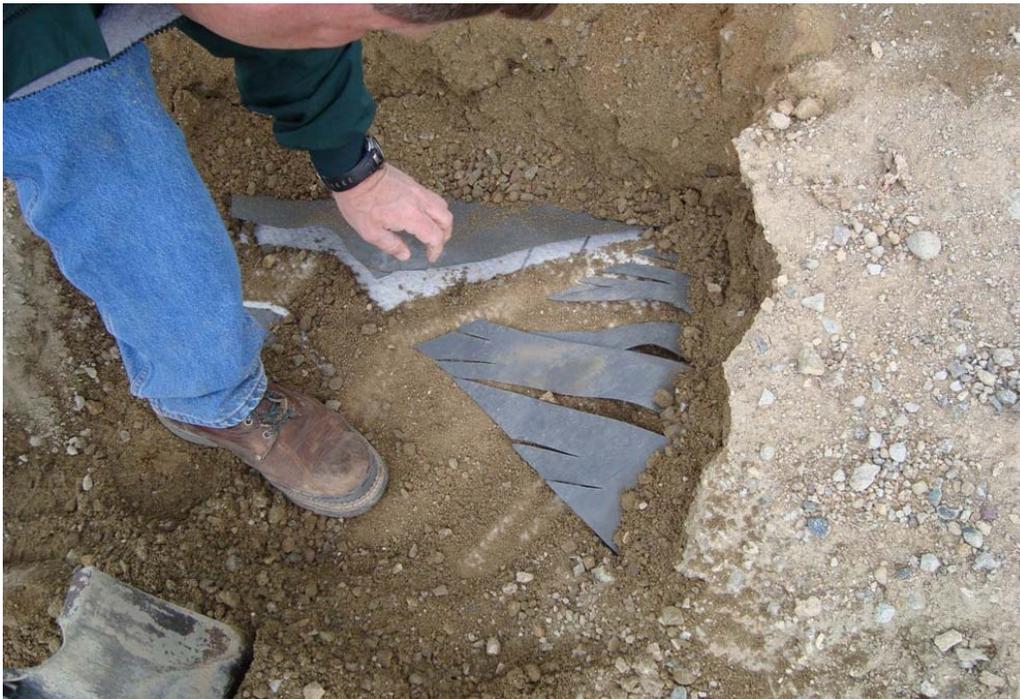
The failing interface was clearly between the PVC and the GCL. The exposed GCL appeared unstressed and undamaged.

Very little bentonite was observed on the top of the GCL's upper NW geotextile. The bottom side of the PVC was observed to have a thin film of moisture (Figure 5).

Figure 5. Standing on exposed GCL (obscured with sandy gravel cover) and lifting edge of torn PVC. Clean white GCL can be seen been raised edge of torn PVC. Condensation water was noted on bottom side of PVC.

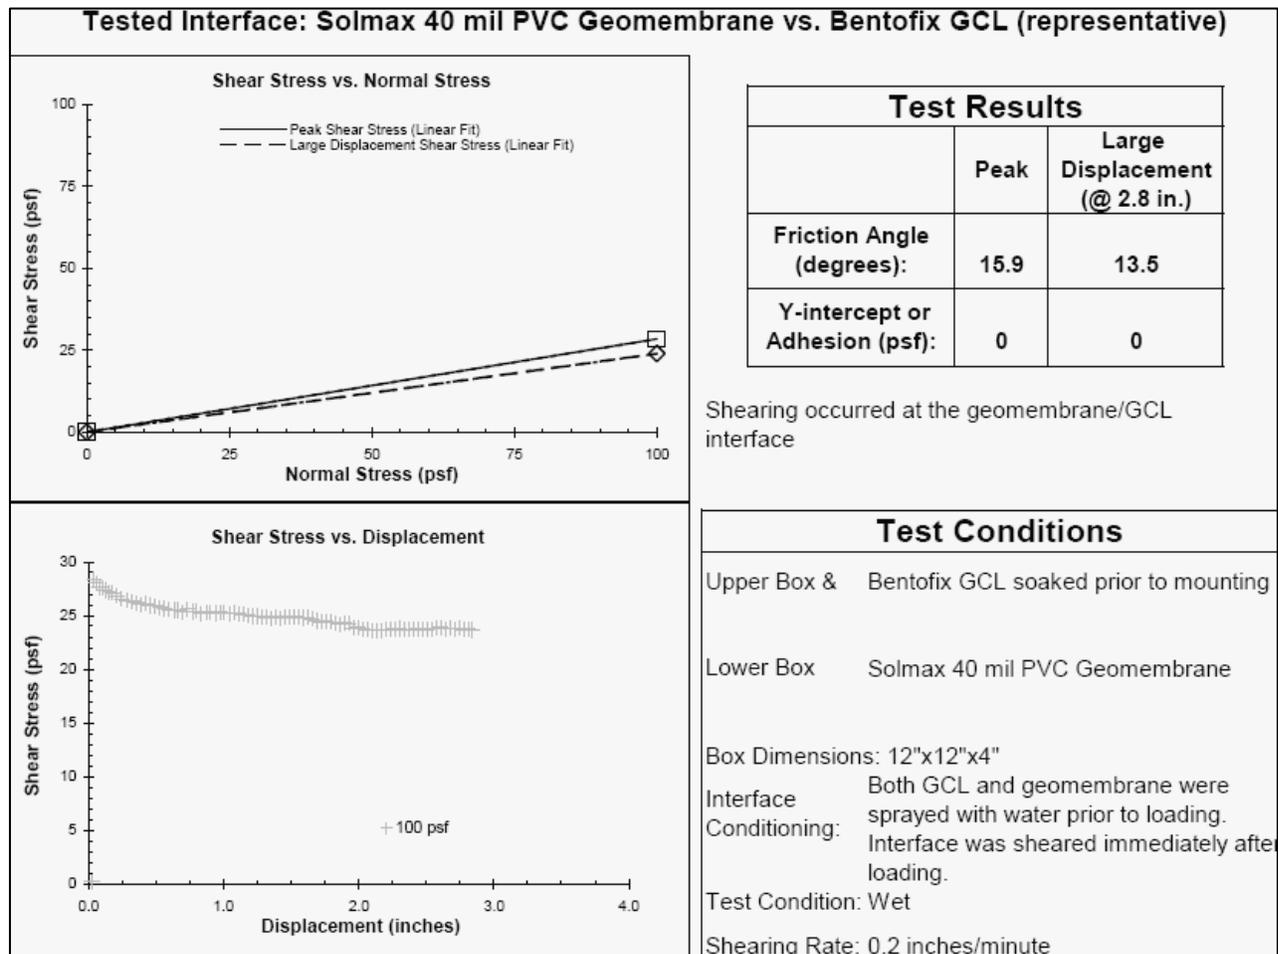
The last observation led the author to immediately commission the same laboratory used by the designer to perform a single-point shear test at 4.8 kPa (100 psf) normal load where the interface was sprayed with water immediately prior to shearing (a very common procedure when performing interface shear testing during the design phase). Using the same laboratory, equipment, and technician would remove inter-laboratory variations in test values. The test was performed with virgin materials with insignificant pre-hydration or consolidation, and sheared at 5.0 mm/min. Although other test parameters could have been used, these were the parameters chosen by the author given that he only had this single test opportunity on this project. The measured shear strength was a peak secant friction angle of 15.9 degrees and a post-peak angle of 13.5 degrees (Figure 6). These results, showing peak and post-peak frictional strength parameters straddling the slope angle, are indicative of a high probability of failure. These results also show what a large difference there is between a dry PVC/geotextile interface versus a wet one.

Figure 6. Direct shear test results: Interface sprayed with water before test assembly.

- The presence of free water is almost guaranteed in the field conditions at the geomembrane interface with underlying earthen subgrades.
- Sandwiching a GCL against a geomembrane in a dry state, loading, and then hydrating may have a very low likelihood of allowing any free water to reach the geomembrane interface.
- Laboratory direct shear testing with geomembranes against surfaces that will have access to soil moisture should always be sprayed with water before assembling them in the shear box.

1. Projects need to evaluate stability for construction conditions; not just final operational conditions. In this case, this would have meant evaluating the slope stability for the veneer system by performing interface shear strength testing at the appropriate low normal loads.
2. Direct shear tests involving clays or GCLs against geomembranes need to have the geomembrane interface sprayed with water before the test materials are assembled. Simply flooding the assembled test "sandwich" may never allow the interface to become wet. Under field conditions a deployed geomembrane will have condensation water on its bottom surface within a matter of hours, and thus spraying the interface with water is representative of field conditions. There can be a large difference in shear strengths between a dry interface and a wet one.
