Concern for GCL Shrinkage when Installed on Slopes

R.Thiel¹ and G. N. Richardson²

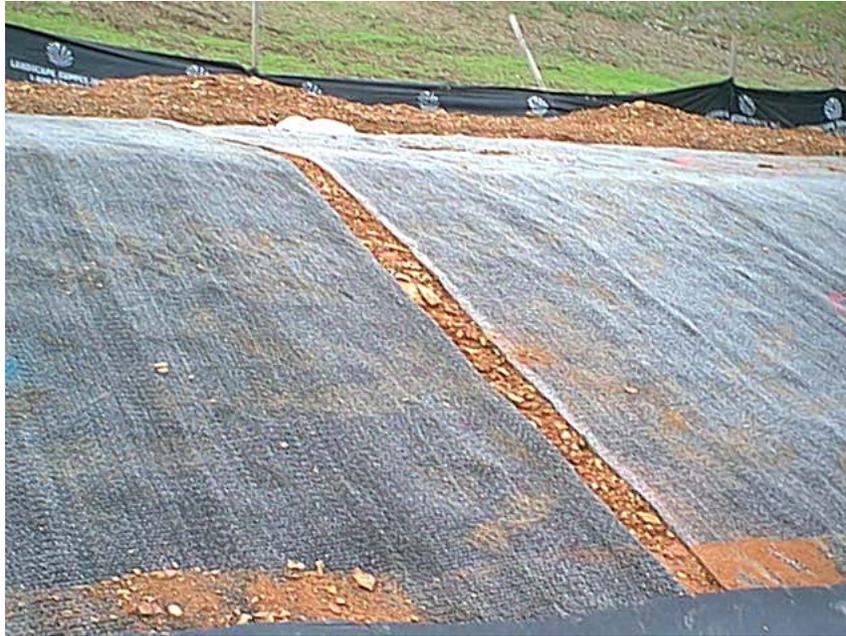
A composite liner system composed of a double nonwoven needlepunched GCL placed under a textured HDPE geomembrane was constructed in Roanoke, Virginia. Approximately 140,000 square feet of GCL and geomembrane was placed in May 2000. During soil covering on a 3:1 side slope, the embossed textured HDPE geomembrane slid on the GCL interface. For four months work was halted while the slide situation was being addressed. Most of the area was left uncovered with soil during this time, and thus the geomembrane was left exposed with the underlying GCL. When work resumed in October, it was decided that the geomembrane had to be removed and replaced with a more aggressively textured material. Upon removal of the geomembrane there were gaps noted in about 30,000 square feet of the installed GCL, repeated in 15 to 20 seams. While the overlying geomembrane may have moved, no movement of the GCL relative to the subgrade was observed over the entire time period. The GCL panel edges had initially been overlapped by at least 6 inches, and now many had gaps of 2 to 3 inches. Figure 1 shows a photograph of a typical gap. All of the seams were cap-stripped with a 2-foot wide strip of GCL before continuing with the project.

Figure 1. Photograph showing gap in GCL panels after removal of geomembrane.
