Evaluating a leachate pond geomembrane after 25 years of service

by Richard Thiel

This article reports on the evaluation of an exposed geomembrane liner in a landfill leachate pond after being in service for 25 years. The evaluation was performed in two campaigns: in August 2014 and in May 2018. The purpose of the evaluation was to determine the condition of the geomembrane and to provide a recommendation to the owner on whether or not it was in need of imminent replacement. The results of the evaluation indicate that the geomembrane appears to be in decent condition and is expected to last some number of additional years, but the definitive number is not possible to estimate. Based on the work performed in 2014, it seems that the material is still readily repairable, if need be. Recommendations for future periodic inspection and testing are provided herein.

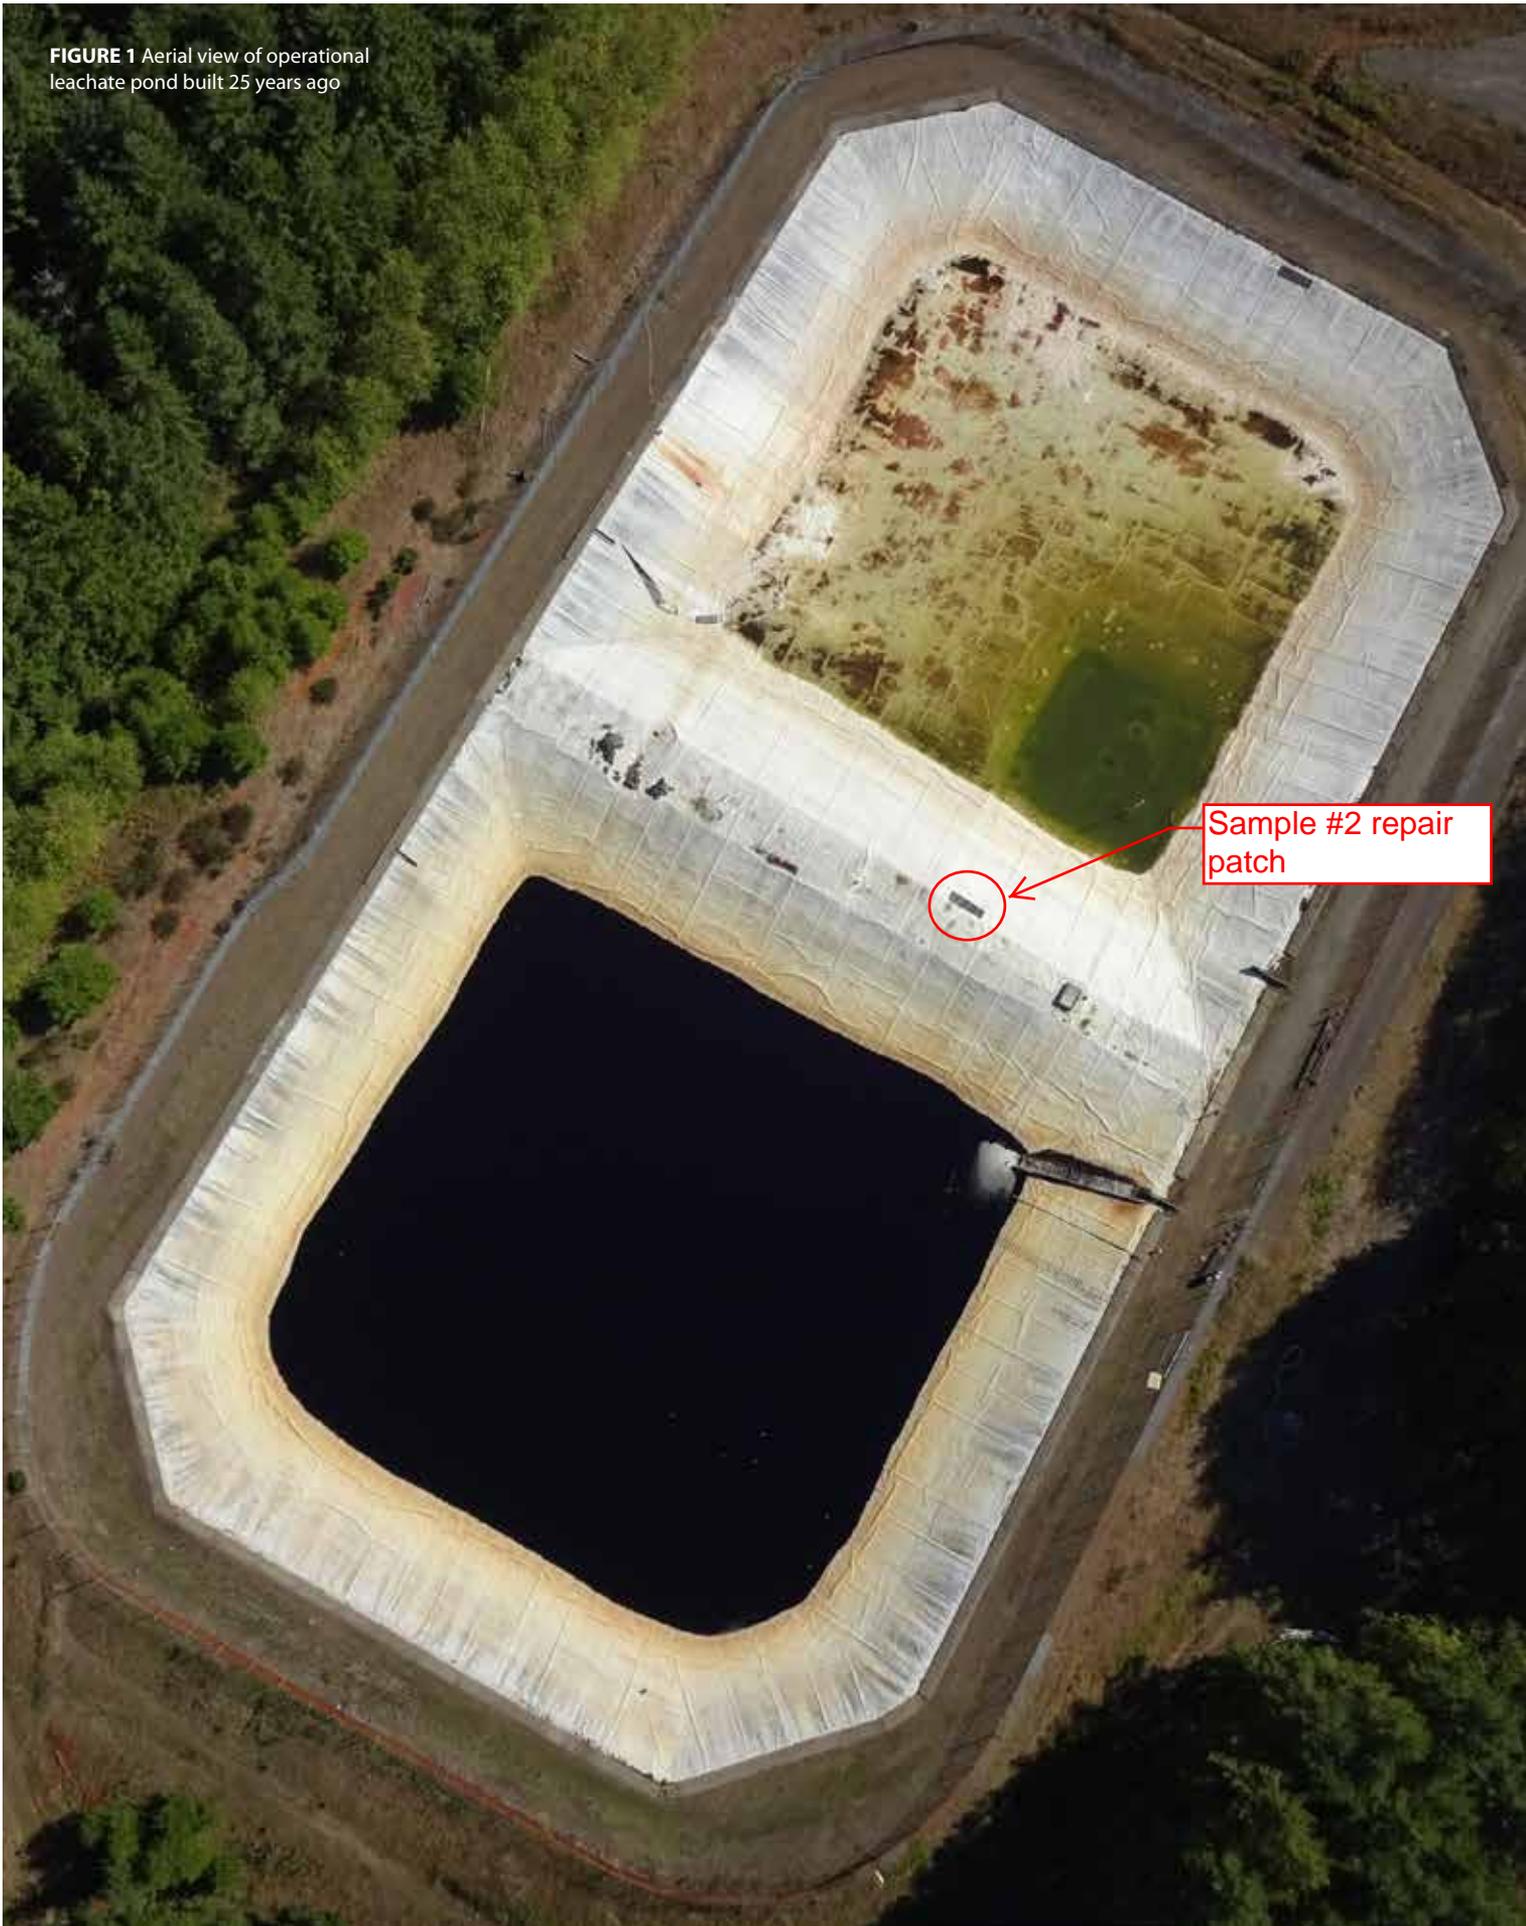
FIGURE 1 Aerial view of operational leachate pond built 25 years ago

The leachate pond is a 5-million-gallon (19-million-L) double-lined leachate storage pond that was constructed for the Headquarters Landfill in Cowlitz County, Wash., in 1993. The pond is designed with a dividing berm that partitions the pond into two equal, symmetric halves. The dividing berm is lined over its top so that the liner system is continuous between the two pond halves. The southern half of the pond has historically contained various levels of clean rainwater, with only occasional containment of leachate toward the end of a few wet winters. The northern half of the pond has historically been the primary management basin for leachate storage, and its sump is used for leachate transfer via an outlet pipe. **Figure 1** shows an aerial view of the ponds.

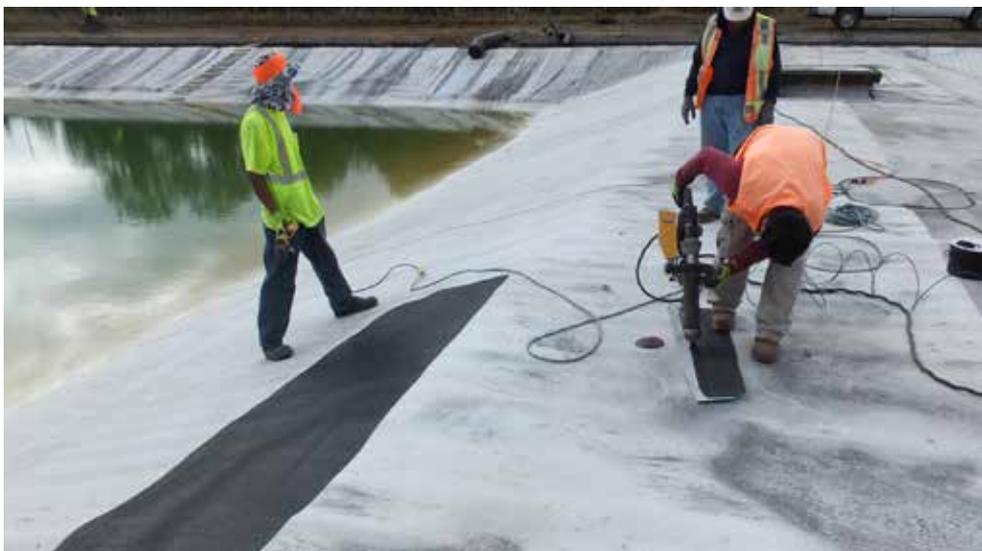
Visual inspection of the exposed and cleaned geomembrane in both halves of the pond indicated the geomembrane to be in good condition with no signs of degradation or cracks. While no repair welds were required in 2018, the repair welds performed in 2014 appeared to be successful with excellent trial-weld field test observations. **Figure 2** shows a patch being installed on the sampling location, **Figure 3** shows the beginning of removing sludge from the northern half of the pond in 2018, and **Figure 4** shows the empty northern pond after cleaning.

FIGURE 2 Patching a hole in pond liner where sample was taken for testing in May 2014. The photograph shows trial weld being performed where new HDPE is being welded to old pond liner.

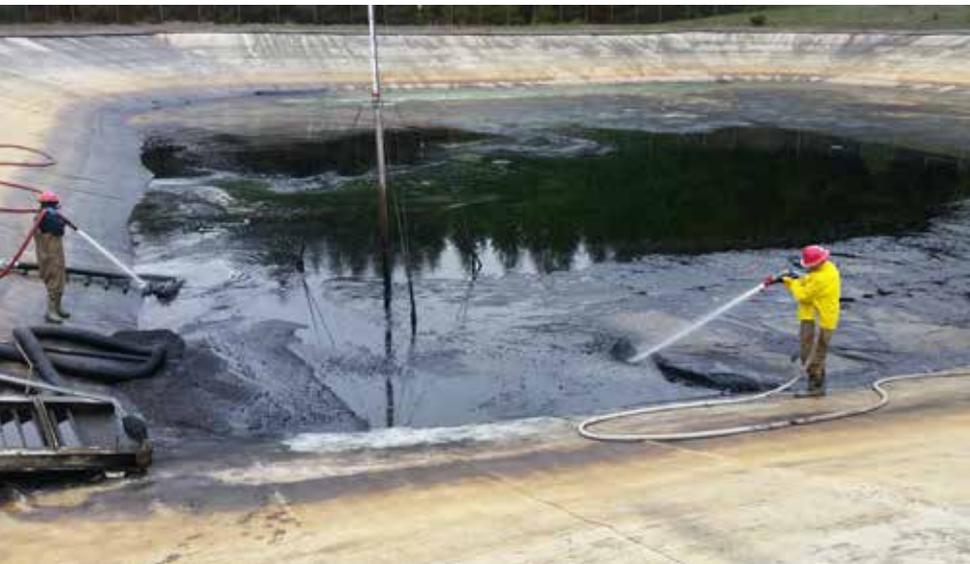
pond that typically contained clean rain-water, and Sample #4 was taken from the northern pond that had continuously contained landfill leachate. Due to sediment and sludge buildup around the outlet in the sump of the northern pond, that pond was cleaned in April 2018. The southern pond also had to be completely emptied and cleaned at this time, because it had been used temporarily for leachate management in the past winter and needed to be prepared to store clean water again. The cleaning activities in both ponds at this time allowed access to the pond bottoms where samples could be cut from existing loose rub sheets. It should be noted that the conditions of the rub sheets would be conservative in the sense that both sides of the rub sheets

FIGURE 3 April 2018 cleaning sludge from northern half of pond

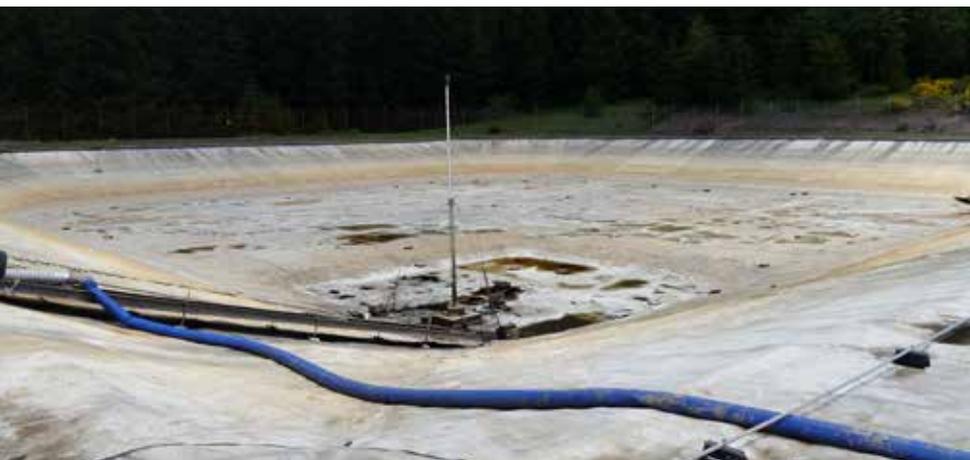
FIGURE 4 April 2018 northern half of pond after cleaning

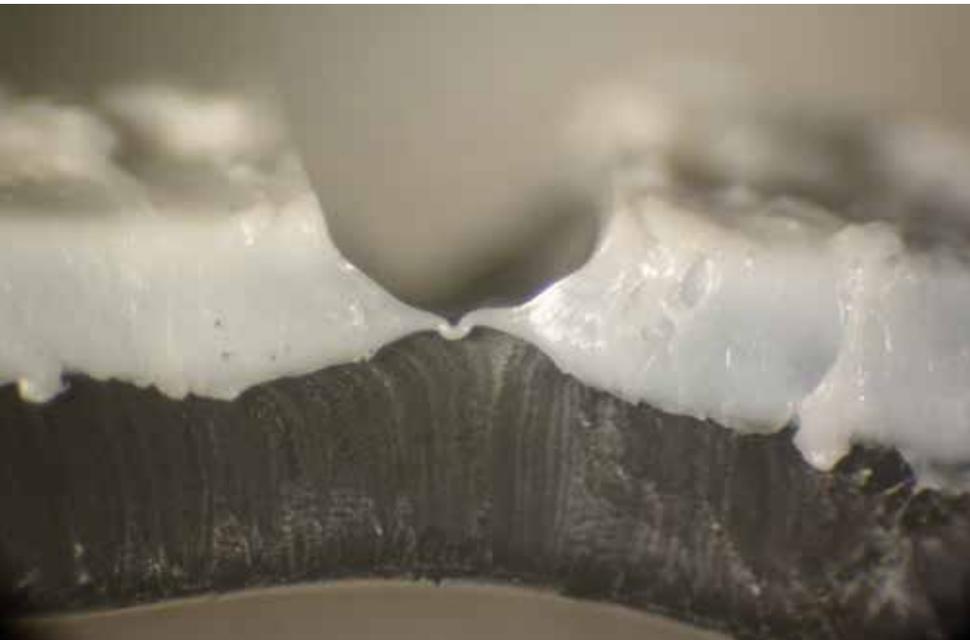
The key performance test result is the SP-NCTL stress crack test data, in which all samples continue to perform well.

FIGURE 5 Photograph from 2014 of original razor-blade slit that extended through the white surface into the VLDPE core. During the NCTL stress-crack test, the sharp notch eventually blunted and did not propagate, which is a testimony to the functionality of the VLDPE core to resist stress cracking. No photographs were taken in 2018, but the NCTL results indicated continued very strong performance for this test.

In 2014 the testing laboratory took some close-up photographs (e.g., **Figure 5**) of the razor-blade slit in the test specimen during the SP-NCTL test. It was clear, even in such photographs, that blunting of the sharp razor cut had occurred during the test due to the performance of the VLDPE core and that cracks will not easily expand through the VLDPE layer. This provides further confidence that a sudden failure may not be catastrophic, especially considering the presence of a complete secondary geomembrane and leakage collection layer between the primary and secondary geomembranes.
