## GCL Shrinkage and the potential benefits of heat-tacked GCL seams

### ABSTRACT

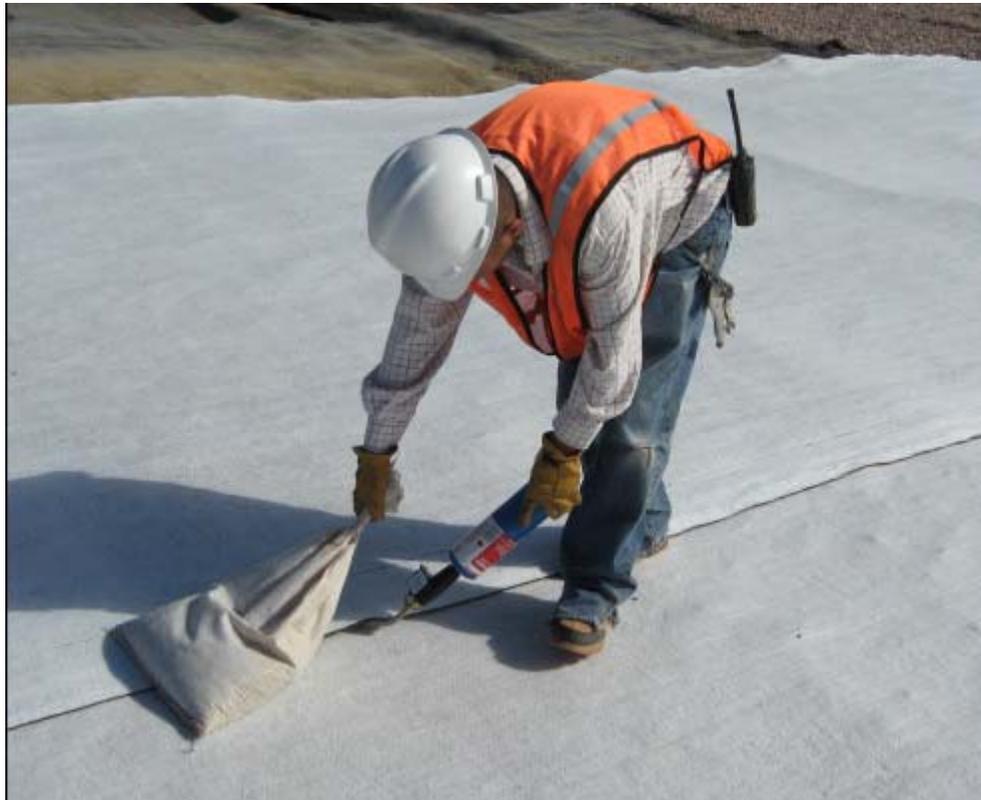
Figure 1. Installer heat-tacking GCL edge seam with a 150 mm overlap.

Thiel (2008) recently proposed a novel field approach to addressing the concern regarding separation of GCL panels forming part of a composite liner for a large (60ha) heap leach pad at the Carlota Mine in Arizona, USA (latitude 33°N). The pad was constructed in an alluvium deposit consisting primarily of eroded Pinal Schist, Schultz Granite and Dacite materials. The subgrade upon which the liner was placed was moderately to highly weathered bedrock in the form of a gravelly, silty sand that breaks down during mechanical compaction and surface rolling. The material is of low plasticity and is subject to rapid drying in the local climate. The moisture content (MC) during compaction was 10% to 12% but due to the arid climate, the moisture content dropped off with depth. Depending on the time installed (i.e. proximity to rain events) and the location within the leach pad the subgrade moisture content may have varied between 5% and 20% when the GCL was placed. In some areas a double-nonwoven, needle-punched GCL was used because of its enhanced shear strength, even though this particular GCL experienced the greatest shrinkage in laboratory tests and in field cases where loss of overlap had been observed. In other areas where shear strength was not as critical, a woven-nonwoven, needle-punched GCL (which was slightly less expensive) was used. Each 150 mm GCL panel overlap was heat-tacked with a quick application of a flame torch followed immediately by light pressure (Figure 1). The geomembrane was then placed over the GCL (same day) but it was often 60 days or more before cover soil was placed. To verify that the GCL overlaps had remained intact, the CQA firm cut holes through the geomembrane to exhume the GCL in areas that had been unballasted for more than 60 days. Both the double-nonwoven and the woven-nonwoven GCL products were evaluated. The exhumations were performed at mid-slope in six separate areas of the project

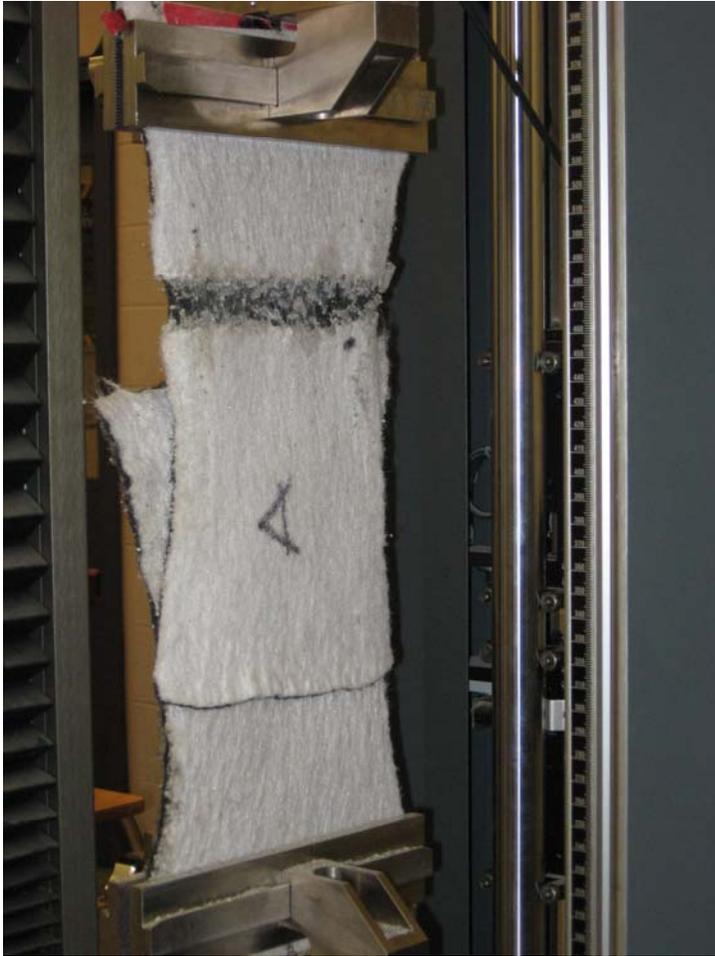
Figure 9. Tensile failure of specimen by pre-engineered groove.

Following the conclusion of the test at 40 cycles, the sample was removed from the pan and the remaining heat-tack strength was tested as per ASTM D4595. The results (summarized in Table 3) show that the strength of the bond following the wet-dry cycling was greater than the seam strength obtained in two tests on virgin seams. Given the method adopted for forming the seam, some variability in seam strength can be expected and it is not implied that shrinkage necessarily strengthened the seam – but it certainly did not appear to have decreased the seam strength in this case. In the tensile test, the sample failed at the pre-engineered groove at the roll edge (as shown in Figure 9), indicating that the heat-tack had in fact held; hence, it may be inferred that the seam strength was greater than the value indicated in Table 3. In these cases the capacity of the heat-tacking to prevent separation will be controlled by the GCL strength at the groove.
