Update on designing with geocomposite drainage layers in landfills

Part 4 of 4: Geocomposite lamination specifications

By Richard Thiel and Dhani Narejo

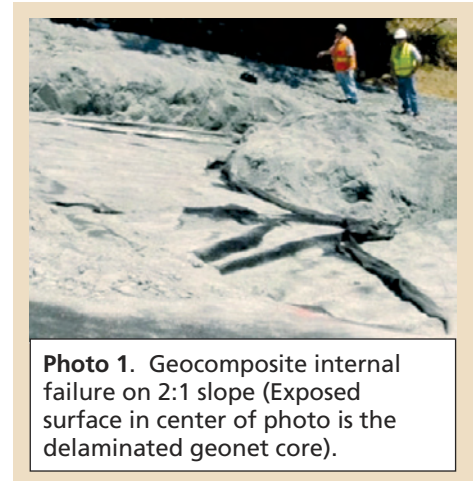
Photo 1. Geocomposite internal failure on 2:1 slope (Exposed surface in center of photo is the delaminated geonet core).

The case-history project required installing a geocomposite drainage layer as part of a landfill cap system on a 40 m long 2(H):1(V) slope. The design required placing a sand layer on top of the geocomposite to act as a filter/separator followed by the overlying vegetative layer. At the point that the sand layer was pushed approximately half way up the slope, the upper geotextile of the geocomposite was observed to tear. Delaminated areas became visible just above areas of the push. Upon returning to the site the next morning, the sand and the top geotextile on the drainage geocomposite had slid down-slope further and the geotextile had torn at the top of the slide (**Photo 1**), though no equipment had been active during the night.

However, on-site inspection of the material as it was being deployed revealed a large variance in the degree of bonding between the geonet and geotextiles. Some areas were very difficult to peel apart, other areas were easier. Many areas of the panels displayed outright delamination between the geotextile and the geonet, which we termed "blisters." Many of the delaminated areas were relatively small, but some were significantly larger (e.g., greater than 1 m²). Furthermore, the material supplied for the case history was manufactured with 0.3 m unbonded edges, such that a butted seam would result in a continuous unbonded zone 0.6 m wide from top to bottom of slope.

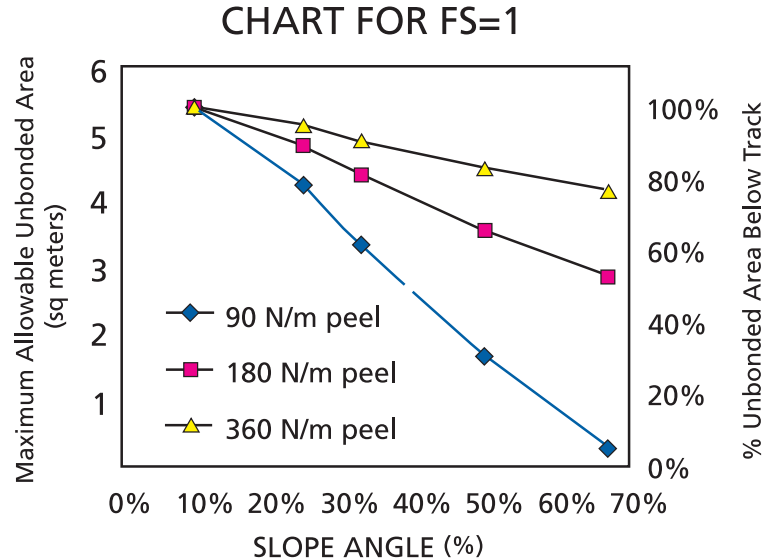
Figure 2. Maximum allowable unbonded area in geocomposite lamination below dozer track area for FS = 1.

By spreadsheet analysis of **Equation 2**, we could estimate what area below the dozer track needed to be bonded to achieve a balance in shear forces ($FS = 1.0$). The data was reduced to indicate a maximum allowable unbonded area for different slopes and assumed initial adhesion (peel) strength assuming the dozer weight and dynamic forces described above. **Figure 2** presents the results graphically for a factor of safety of 1.0.

As expected, the results depicted in **Figure 2** indicate that the allowable unbonded area decreases with increasing slopes. Moreover, significantly less unbonded area is allowable as ply-adhesion strength decreases. Using **Figure 2** for $FS = 1.0$, the failure on the 2:1 (50%) slope could have been predicted. **Figure 2** suggests that if the local bonded peel strength were at the current industry-recommended minimum of 90 N/m (0.5 ppi), then an unbonded area as small as 1.7 m² (18 ft.²) could result in failure. This amount of unbonded area directly below a dozer track would have occurred simply due to the edge seams!

The current state-of-practice and general industry opinion has suggested that a 90 N/m (0.5 ppi) MARV peel strength is adequate for most applications. The results of the current evaluation, as depicted in **Figure 2**, suggest that even on slopes as flat as 4:1 (25%), progressive delamination could occur with equipment operations on the slope if unbonded areas on the order of 4 m² exist when the bonded peel strength is only 90 N/m (0.5 ppi).

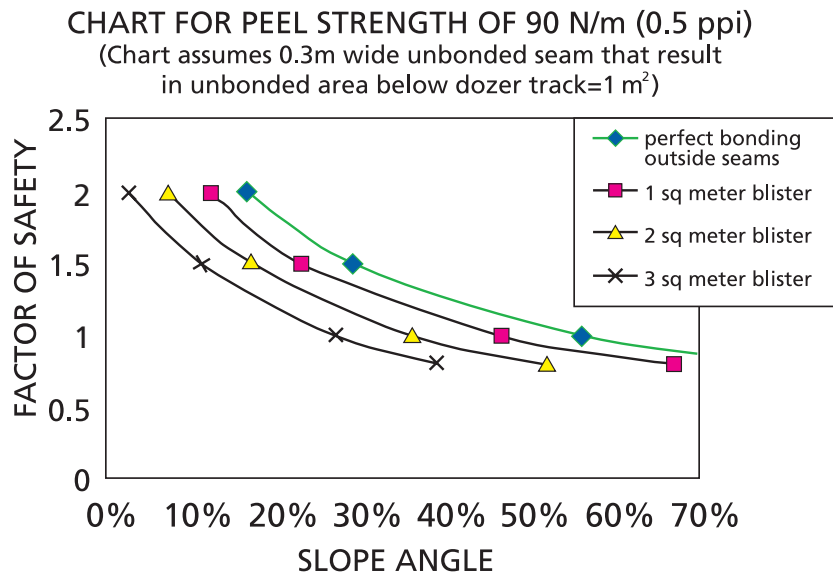
Figure 3. Chart for peel strength of 90 N/m.

The model results were graphically reformulated in terms of slope angle versus factor of safety for a given peel strength and standard unbonded seam width of 0.3 m, as well as for various blister sizes, as shown in **Figures 3 and 4**.

The authors do not intend that **Figures 3 and 4** are definitive representations of what actually occurs in the field. At this point, however, we have at least one field failure and some lab testing indicating that this approach may be on the right track. Given the high levels of uncertainty regarding the actual distribution of shear stresses and dynamic forces that might occur in the field, combined with the inherent variability in the heat lamination process, the authors suggest that using a factor of safety greater than unity, such as 1.5, would be prudent to take into account these unknown factors until more is known about the specifics of the failure mechanics.
