## Practical Guidance on Specifying GCL Overlaps to Account for Shrinkage

This article provides preliminary recommendations for developing project-specific specifications related to the amount of GCL overlap required to compensate for potential panel shrinkage. These recommendations are based on an ongoing laboratory investigation that has been developed to replicate observed field conditions where GCL shrinkage has occurred. Although these results are preliminary, it was felt that publishing these recommendations at this time is appropriate given the seriousness of the concern.

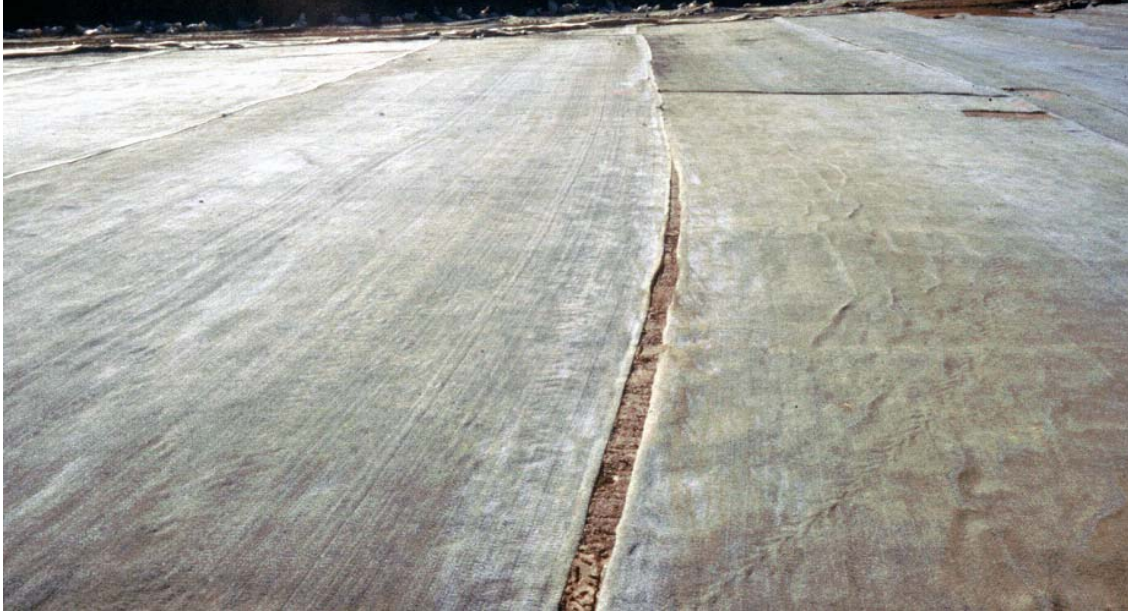
Photo 1 - Observed Field Separation of GCL Overlaps

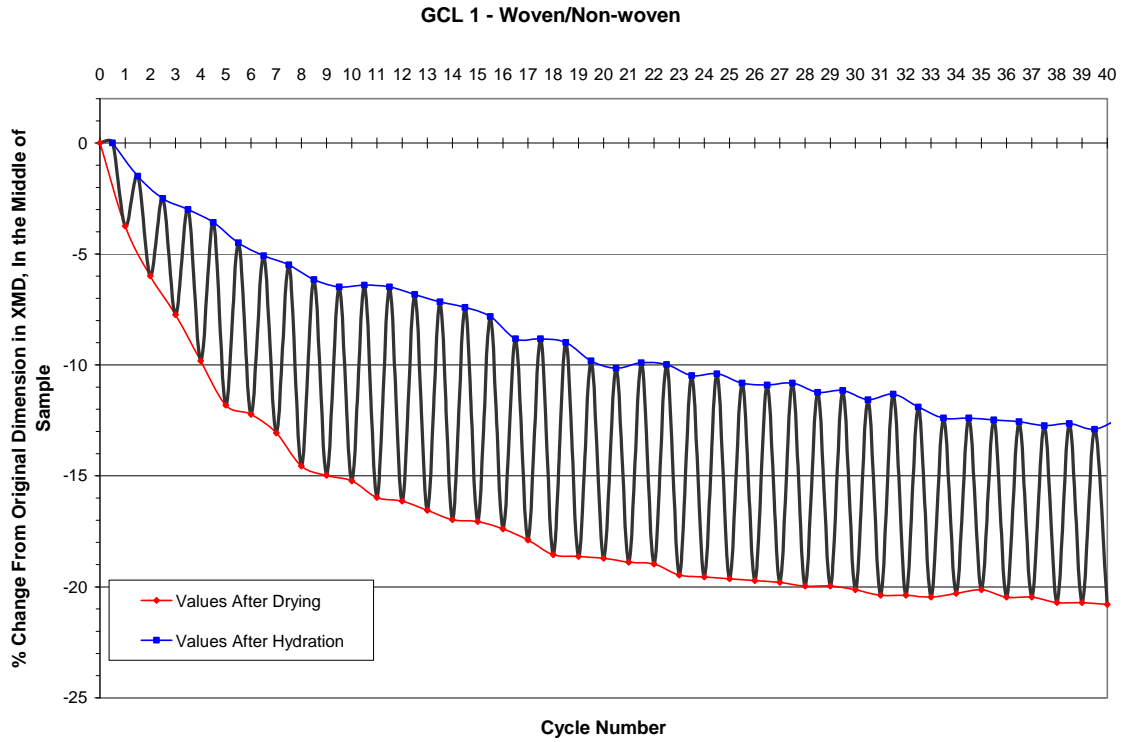
Figure 1: Shrinkage of Sample Direction During Test Cycles: in Cross-Machine

The results for one GCL sample are plotted in Figure 1, which shows the percent change in width at the mid-point of the sample for each wet-dry portion of each cycle. The graph indicates that shrinkage occurs with each dry-side of the cycle, some recovery of the shrinkage upon re-wetting, but never complete recovery. For the sample shown, after 20 cycles there was approximately 10% of irrecoverable shrinkage on the wet-side of the cycle, and 20% shrinkage on the dry-side of the cycle. If the original panel width had been 15 feet, then these results would represent 1.5 to 3 feet of shrinkage, which is towards the upper end of what has actually been observed in the field. To date our laboratory testing program has been performed on 5 different fabric-encased GCL products, one geomembrane-backed GCL, one product was performed with two different amounts of water being added, and 5 different geotextiles. The range of response for the fabric-encased GCLs is about a factor of two, as shown in Figure 2. The geomembrane-backed GCL did not shrink. We have observed a slower rate of shrinkage-per-cycle when less water is added, as illustrated in Figure 3. The geotextiles by themselves exhibited very little shrinkage. Testing of additional products and matrix variables is ongoing.

Admittedly, the results depicted in Figures 1-3 represent worst-case conditions. It is unlikely that most installations would receive as much water as was added during the test, and then be dried to the extent performed in the test on a regular basis. A more likely scenario is that the magnitude of wetting and drying would be smaller on a day-to-day basis. On a seasonal basis, however, it is plausible that there may be extended periods of cool, overcast weather that would allow a fairly complete hydration of the GCL. Conversely, there may be extended periods of hot sunny weather that substantially dry the GCL. Thus, there may be small daily cycles superimposed on more significant seasonal cycles. This area definitely needs more research. A critical area that may experience the extremes simulated in the testing is at the toes of slopes, as described below.

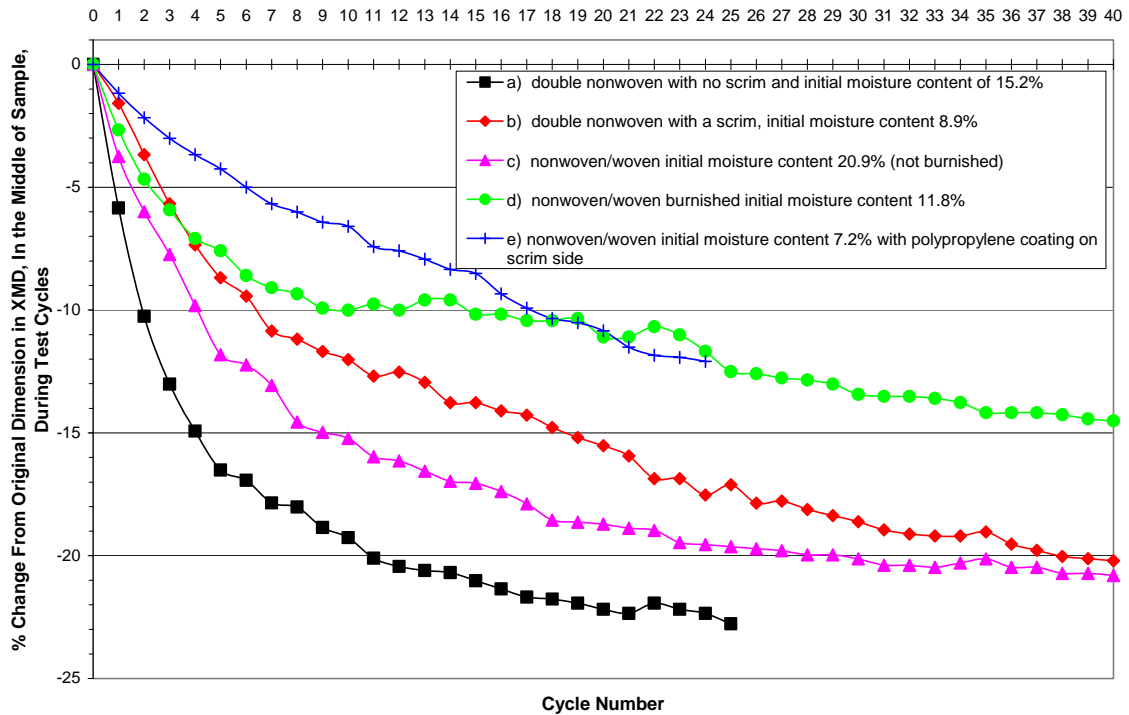
Figure 2: Comparison of Dry-Cycle Shrinkage Results of 5 Different Products

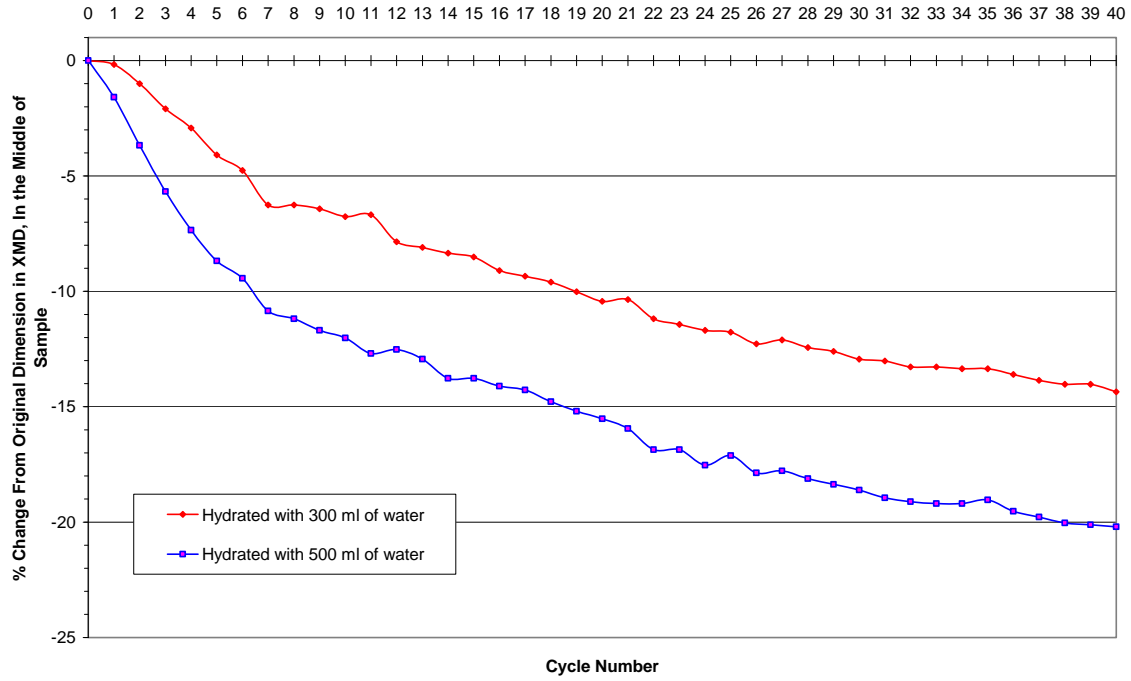
Figure 3: Comparison of Shrinkage Results with Two Different Amounts of Water Addition on One Product

GCL 2 - Double nonwoven with a scrim, initial moisture content 8.9%
