# CASE HISTORY OF EXPOSED GEOMEMBRANE COVER FOR BIOREACTOR LANDFILL

R. THIEL\*, S. PURDY\*, AND R. YAZDANI\*\*

## SUMMARY:

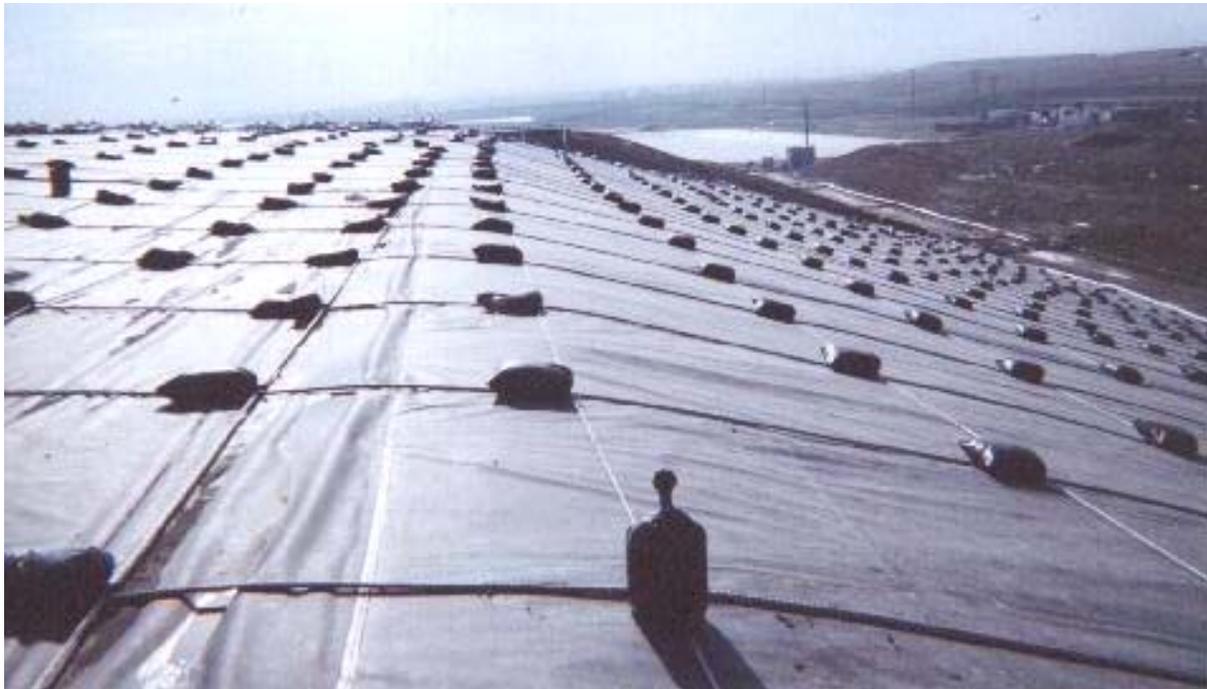
Figure 1. Completed Exposed Geomembrane Cover System from Top Crest of Slope.

consideration for this application. Several other design references are available in the literature describing the approach (Gleason et al., 1998, Gleason et al., 1999, Germain et al., 2001). Using this design method, the only viable hold-down mechanism to keep the cover from being blown away due to a significant wind velocity is to use fully backfilled anchor trenches or soil berms on benches. The primary author believes this is conservative as evidenced by successful designs that have not used such extensive ballasting. Nonetheless, to reduce the probability of failure, the more conservative design approach was used for a maximum assumed wind velocity of 40 m/s. A general picture of the completed cover system is shown in Figure 1.

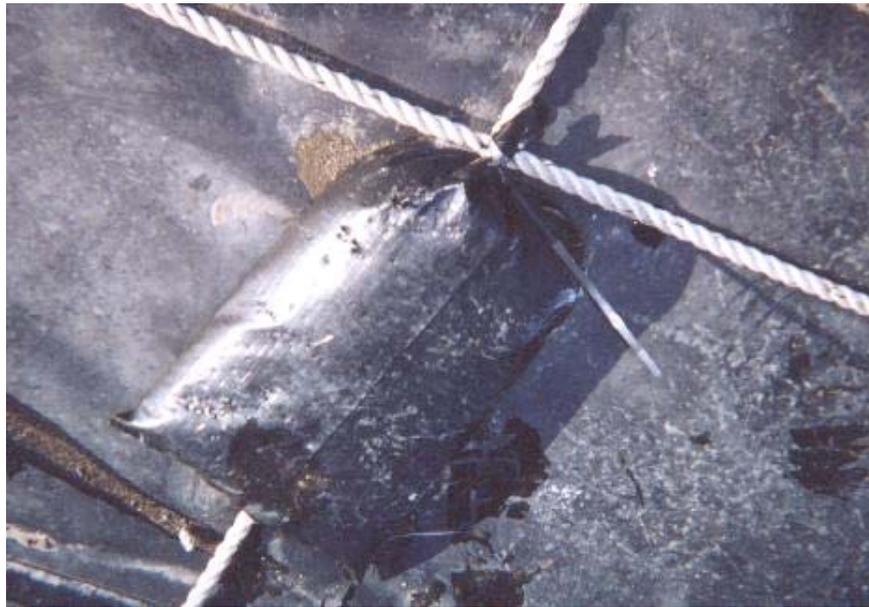
Figure 3. Photo of Sandbag Attached to Rope Node (note bird pecking holes).

The interesting aspect of the ballast installation lies in the exact details of how it is installed and maintained in place. If sand bags were simply to be placed on the liner with no other restraint, the first real wind would cause the sandbags to be tossed around and end up at the toe of the slope. To keep the bags in place, the bags are tethered together with a rope grid made from 3-strand twisted polypropylene rope. The horizontal ropes were specified as 10 mm rope, and the vertical ropes were specified as 20 mm rope because of the greater load they might carry. At each node where the ropes crossed, a sand bag was tied. The type of attachment affects the long-term durability. Plastic electrical ties eventually break due to exposure and stress. Crimped wire hog rings are the most long lasting. Experience has shown that if

It is also important to use sandbags that are durable and have good UV resistance. The material-only cost for a new (unfilled) sandbag at the Yolo County project was approximately \$1 USD. This bag was manufactured from two plies of 0.08 mm polyethylene laminated together having nylon reinforcing threads at a 12 mm spacing each way. Experience has shown this material lasts approximately 5 years in an exposed environment. A typical sandbag attachment at a rope intersection is shown in Figure 3.

The issue of the birds was foreseen, but not to the degree it was actually experience. The two main areas that the birds peck at are the flaps on geomembrane seams, and the sand bags. If the flap left over from welding the geomembrane was left in place, the birds felt an irresistible need to peck inside the flap, thereby endangering the geomembrane. This was solved by cutting away the flap, and the birds stopped pecking on the seams. Solving the issue for the sandbags has been more problematic. The problem became so severe, that tires with covers were placed over the sandbags to protect them. The bottom side of the tires had to be cut out to fit over the sandbags, and a stiff piece of polyethylene geomembrane

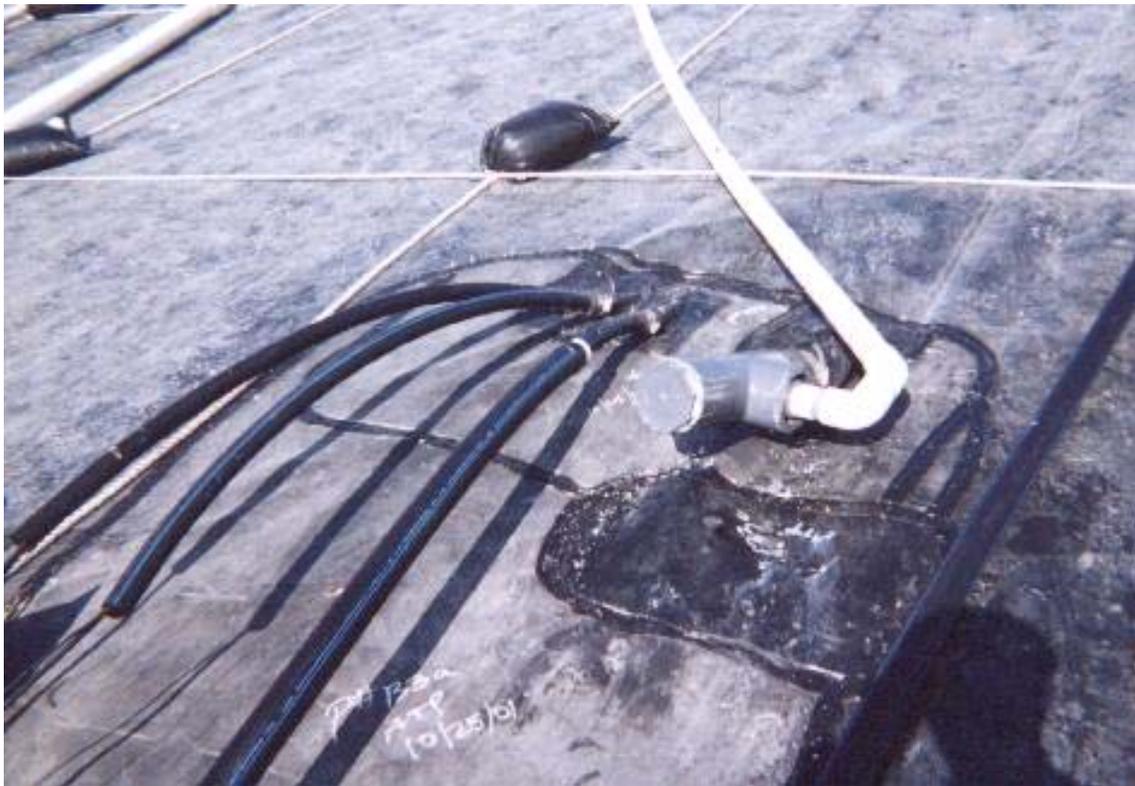
Figure 4. Photo of Pipe Penetration Group.

The type of boot specified for the penetration was a pre-manufactured boot and skirt that could be welded to the geomembrane cover, and clamped to the pipe. In the two years that the exposed cover

system has been operational, only one tear occurred. A photograph of some typical pipe boots is presented in Figure 4.

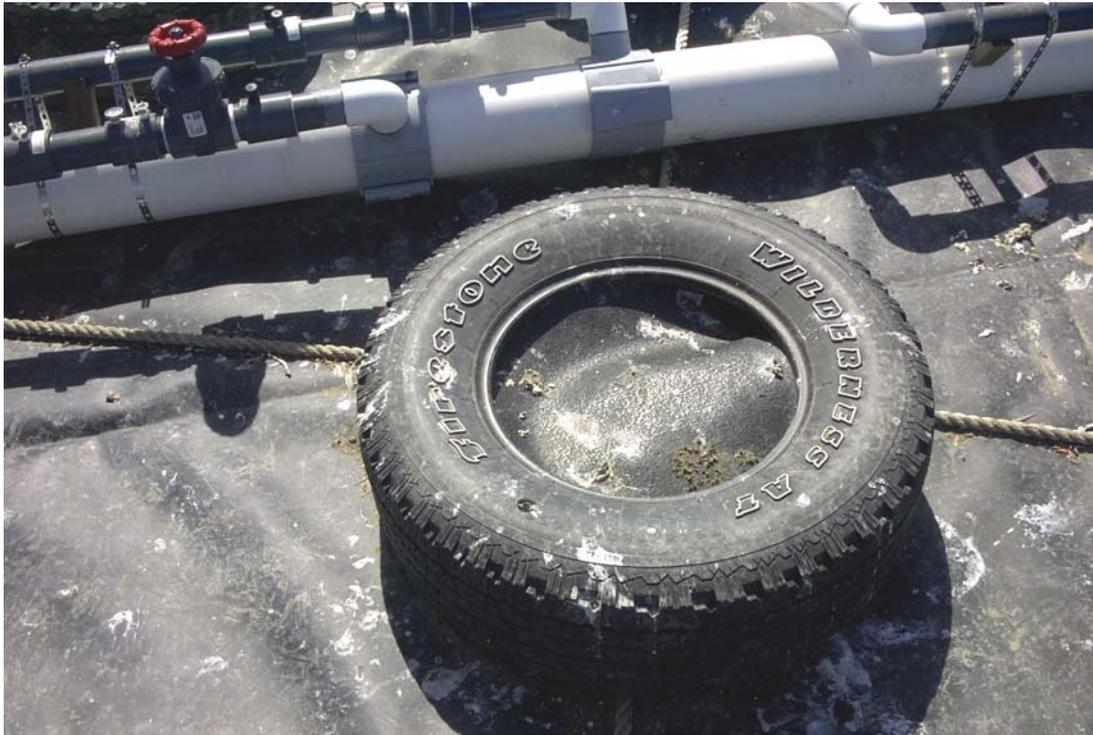
Figure 5. Photo of Tire Protection Over Sandbag.

inserted over the top of the tire to keep the birds out. A photo of the tire protection installation is shown in Figure 5.
