Increasing the Sensitivity of the Dipole Method: A Case Study

Abigail Gilson-Beck, P.E.,¹

Richard Thiel, P.E.,²

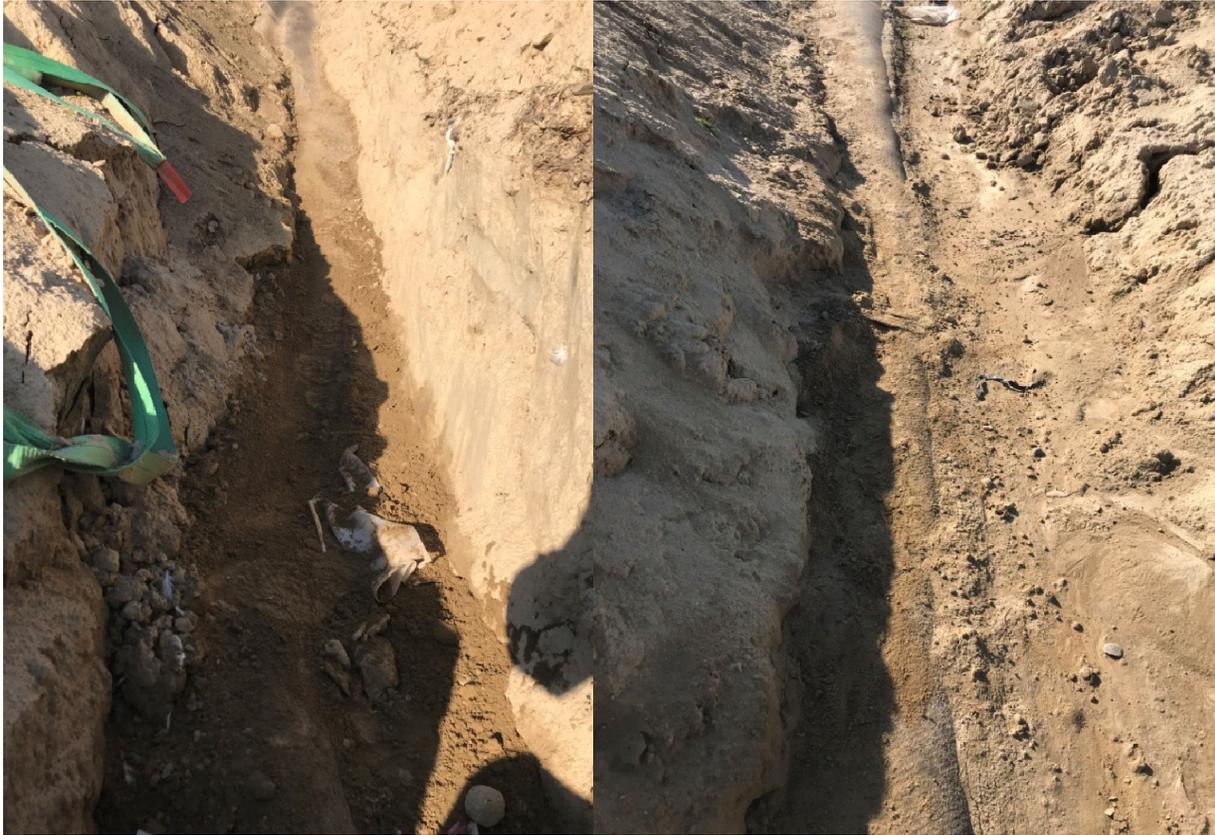
Figure 1. Perimeter Isolation Issue at Access Road Location Causing Primary Survey Portion 3 Sensitivity Issues Before Cleaning (Left) and After Cleaning (Right).

During each survey, the relevant upper soil layer being surveyed (i.e. the 0.3m separation layer for the secondary liner system, and the 0.6m operations layer for the primary liner system) was stopped short of connecting with the perimeter of the new cell to provide electrical isolation. On three sides of the rectangular cell the perimeter consisted of a permanent anchor trench, and on one side the perimeter consisted of a tie-in to a previous cell. At the base of the unconnected gap between the new soil layers and the other side of the perimeter one could visibly see the exposed geocomposite drainage layer over the geomembrane. Electrical isolation was maintained by keeping the exposed geocomposite and geomembrane in this gap relatively clean and dry (Figure 1).

The 3rd portion of the primary liner system campaign showed particularly troubling voltage readings in that both of the functionality measurements had positive values. Without the negative voltage value with the front dipole foot over the artificial leak, the artificial leak is not strongly detectable. After reviewing these results, the perimeter isolation gap was inspected and the isolation improved before beginning the testing. A location along the perimeter immediately adjacent to the location of the artificial leak exhibited a strong signal due to the isolation issues shown in Figure 1. This location was determined to be the cause of the isolation issues upon analysis of the voltage mapping. This type of perimeter isolation issue is very typical of landfill expansions. Also it is noteworthy that the silty/clayey soils comprising the upper soil layers at this site are much more electrically conductive than clean sand and gravel layers that might be used for the drainage and operations layers at other sites, and this increased conductivity exacerbates the isolation issues.

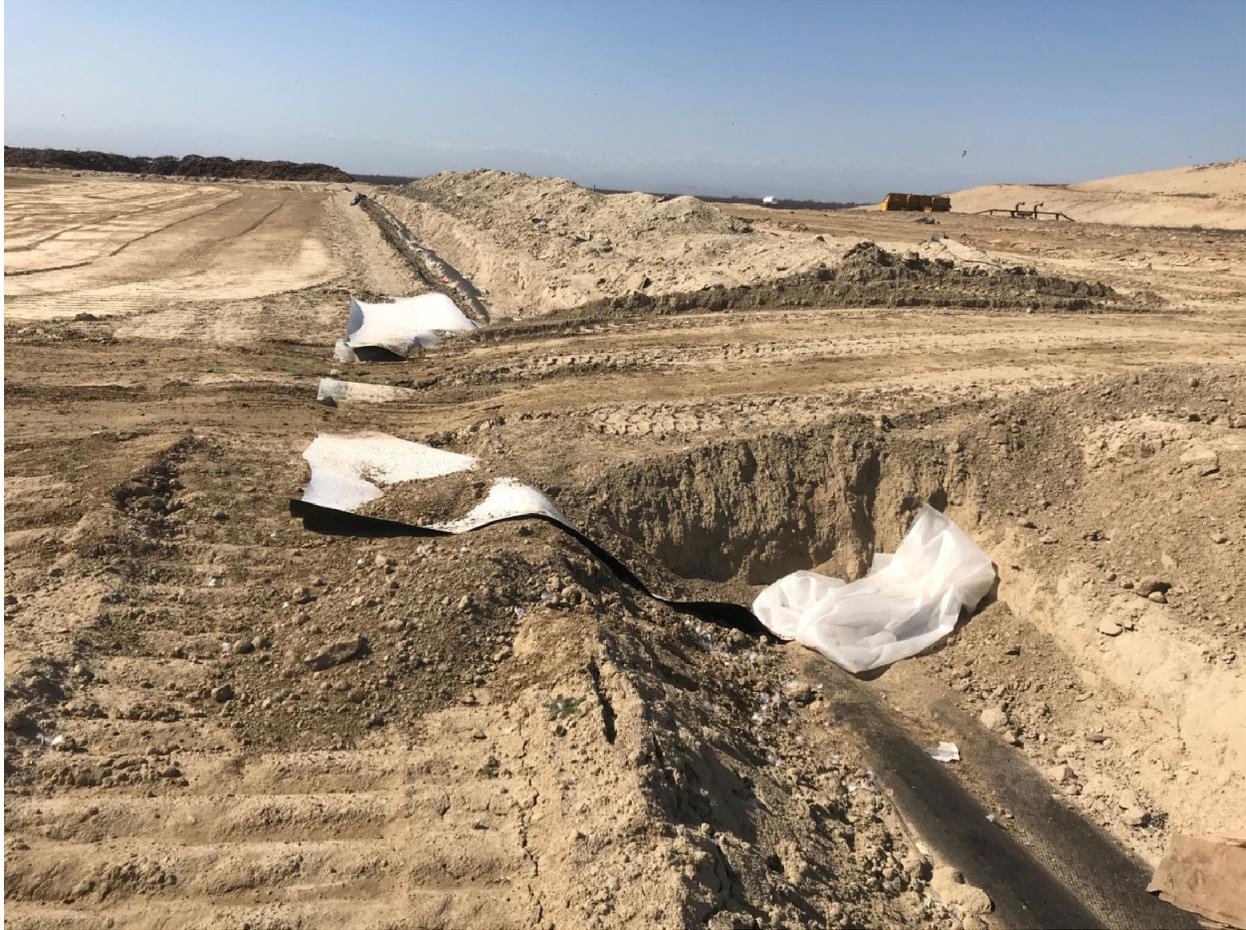
Figure 2. Method of Electrically Isolating Access Roads

The method of electrically isolating access roads to maintain survey area truck access for spray-irrigating the cover soil material was to use a geomembrane flap. The flap was placed across the isolation trench and extended up through the access road soils to create an exposed edge, as shown in Figure 2. Such a flap, if used, is best welded to a rubsheet, which in turn should be welded continuously all around to the containment geomembrane, so that the flap weld does not adversely affect the containment geomembrane.

The entire perimeter isolation gap was then further cleaned and all of the access roads, such as the one shown in Figure 2, were completely removed. Functionality testing was repeated without any significant improvement. The second author was the approving engineer for this project and insisted that the 1/4" artificial leak be detectable before commencing the survey. He suggested the use of a high-powered leaf blower, directed at the geocomposite, proceeding along the entire isolation gap very slowly in order to thoroughly dry out the moisture trapped by the geotextile on the underside, and it would also tend to blow out any loose soil in the gap area. The backpack leaf blower that was used is shown in use in Figure 3.

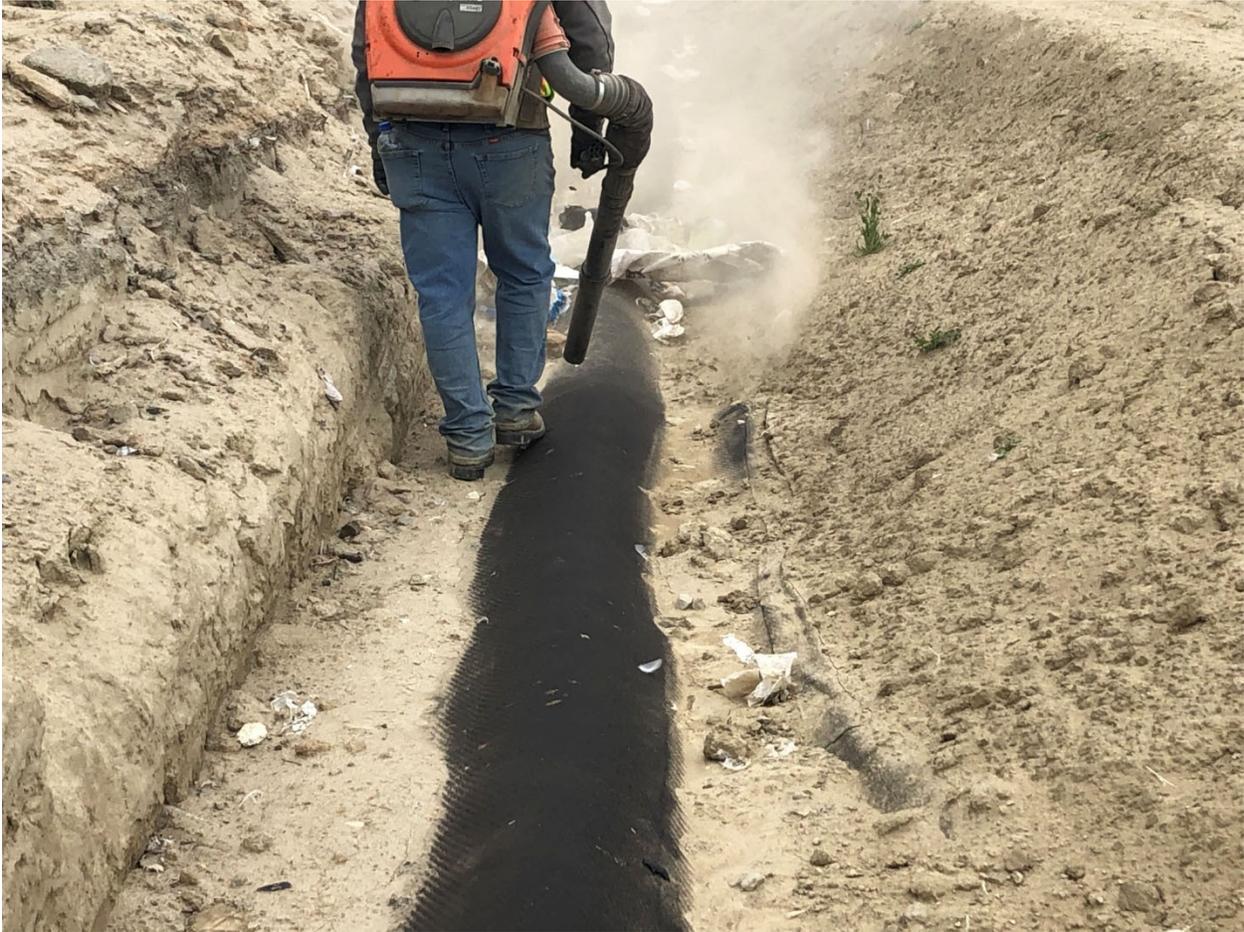
Figure 3. Backpack Leaf Blower Used to Dry out the Geocomposite in the Perimeter Isolation Gap.
